# HYBRID SHORING SOLUTIONS FOR A CHALLENGING EXCAVATION PROJECT ADJACENT TO A SUBWAY – 21 AVENUE ROAD, TORONTO

Thomas Fiala, P.Eng., Isherwood Associates, Mississauga, ON, Canada  
Graeme Smart, P.Eng., Geo Foundations Inc., Acton, ON, Canada

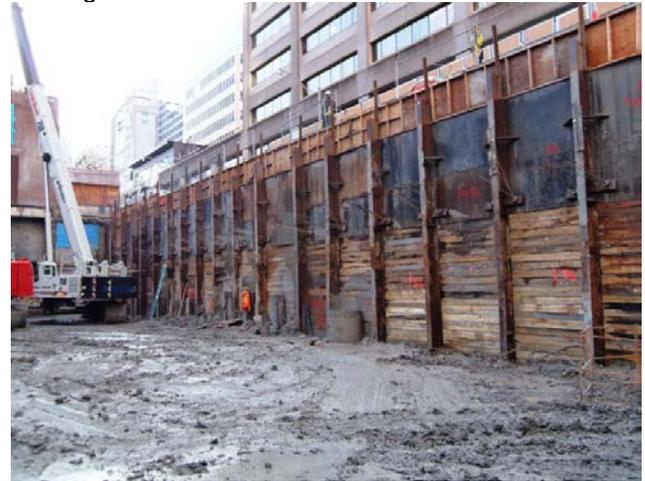
Figure 7: Upper shoring with plates, tiebacks, and lagging

To protect the utilities and reduce movement, a 20-mm thick back flange plate was welded to the top 3 m of the existing piles, the elevation of the first row of double tiebacks. For the next 4 m, lagging was specified to be installed to the back of the piles to provide space for the installation of the new piles. From this elevation, 7 m below grade, new W310 piles were installed to below the base of the outside of the future foundation wall and in front of the old shoring.

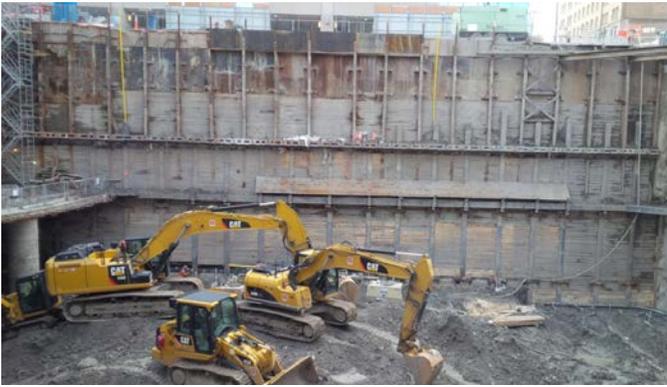
Figure 9: View of south wall excavated to third row of tiebacks

The remaining south wall shoring, below second row tiebacks to final grade, was conventional soldier pile and lagging with two rows of double tiebacks.

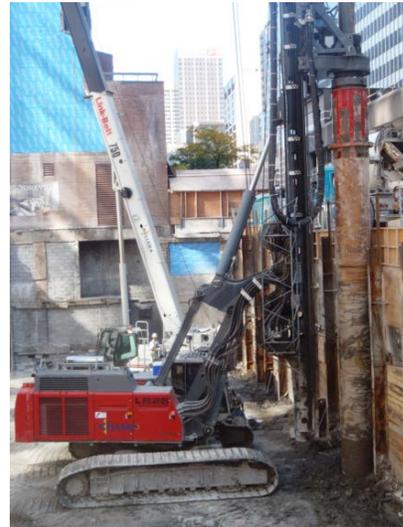
Figure 10: Drilling at south wall

To satisfy the design and installation requirements, a modified drilling procedure was implemented using a Liebherr LB 28 drill rig equipped with 20 m of Leffer casing and a Linkbelt TTC750 service crane. Conventional drilling techniques typically require a minimum clearance of 150 mm from the edge of the existing shoring wall to the edge of the drilled shaft due to the outward projection of the drill rig rotary head. To avoid this installation clearance restriction, a 6 m long casing was used to extend the drive can and keep the rotary head above street elevation. With the rotary head positioned above the existing shoring wall, the temporary casing could be installed flush to the existing shoring.

Using the 6 m drive can extension, a 5 m starter section of casing was installed and advanced to refusal. The drive can extension was then disconnected and augering commenced. Subsequently, the extension was reattached and the casing was advanced further. This procedure was repeated until the 5 m casing length was 1 m above working grade and the next piece of casing could be attached. Using this technique, the hole was advanced to the founding elevation, fully cased, with minimal water ingress.

Using a 610-mm diameter steel pipe hoisted, held in place using the Linkbelt crane, the drilled shafts were concreted from street elevation. The 6 m casing extension was then reconnected at the working grade elevation in order to remove the temporary casing in sections. Once the entire length of casing was removed, a new pile was placed (wet set) with the Linkbelt, flush to the back of the hole. Any difficulty advancing the piles was overcome using the Liebherr LB28 crowd, ensuring the piles all reached the desired depth.

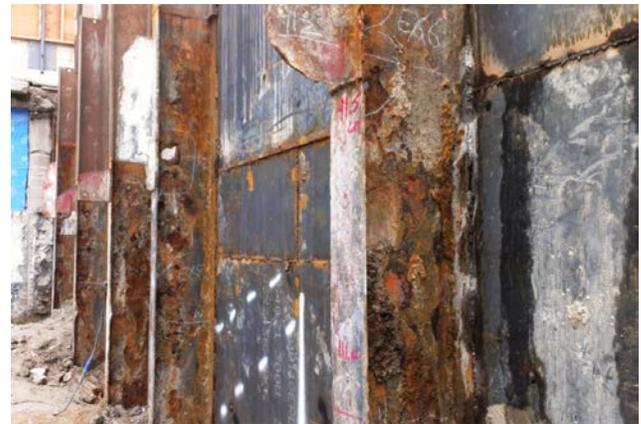
Figure 11: Rust on existing piles

Once the top 2 m of the existing shoring was excavated and the existing piles exposed, significant rusting of the top 1.2 m and varying other portions of the piles was observed. The rust raised concerns of the structural integrity of these piles, prompting new steel splices to the top 1.2 m and replacement of the other rusty sections with welded steel plates.

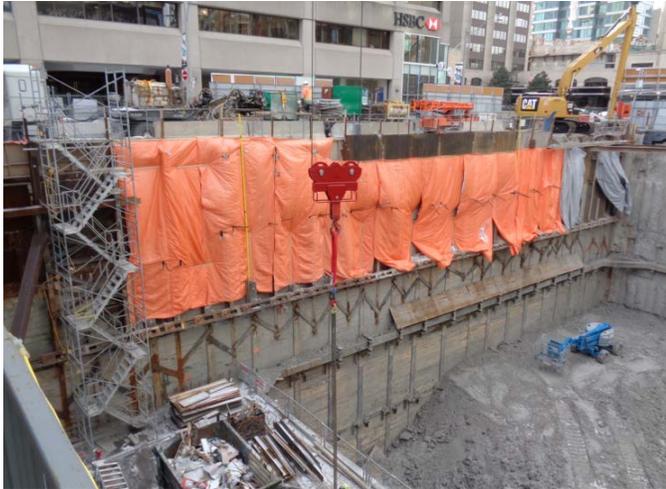
Figure 12: South wall V cross-bracing

When excavation reached the base of the original shoring and the tops of the toes were exposed, Isherwood learned the existing piles had been driven rather than drilled, bringing into question whether there was adequate vertical capacity in the old/existing shoring as the toes were exposed further. As there were no concrete toes, by the time the site had been excavated to the third row of tiebacks, the top shoring had started to settle by over 15 mm, raising concern whether the waler was strong enough to support the vertical load. To address this issue and prevent further settlement, Geo Foundations installed vertical V-shaped cross strapping.

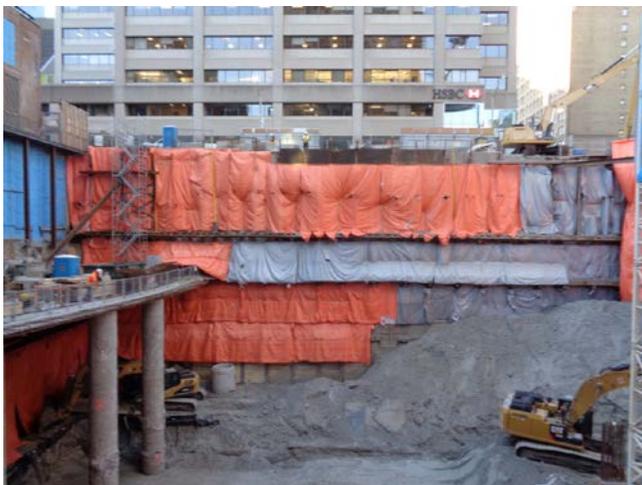
Figure 13: South wall with frost blankets in place

This shoring was exposed during two of Toronto's coldest winters in decades with weeks of continuously below-freezing weather. As a result, there was significant upper shoring movement due to frost. During the first winter (2013/14), with the site excavated halfway down, the top shoring moved up to 23 mm into site due to frost and rebounded back an average of 18 mm in the spring of 2014. During the second winter (2014/2015), frost blankets as well as heaters on the south wall were installed to mitigate the risk of frost movement.

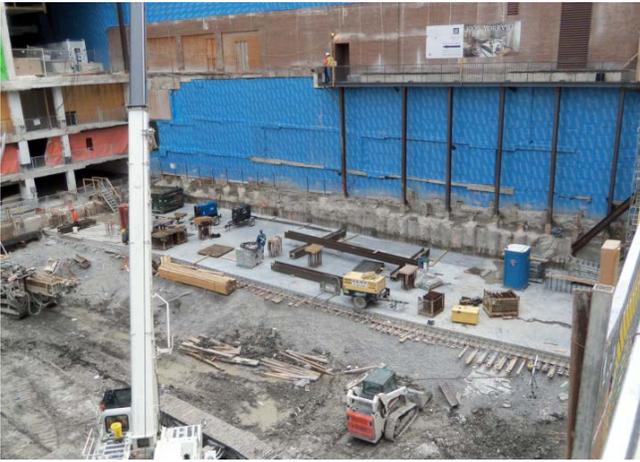
Figure 14: After the piles were installed, the slab was installed by forming on the top of the soil. Structural Engineers Jablonsky Ast and Partners designed the slab.

To secure and brace the footings of the existing building, the partial permanent P3 slab was to be pre-loaded. The slab would have to be strengthened to withstand the pre-loading to 29 MN (2,900 tons). The vertical shoring wall was a secant wall with heavy W610 piles in every second drilled shaft.

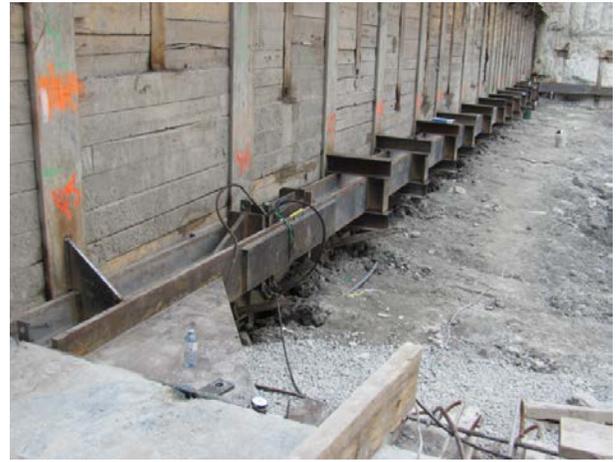
Figure 16: Strut for slab on south wall

Free-moving, pre-loaded struts, which ran the full length of the north and south walls, were braced against the west secant wall and the P3 slab buttress. The connections at the piles needed to prevent the struts from buckling and also allow the struts to slide during pre-loading. After pre-loading, the struts would be welded in place.

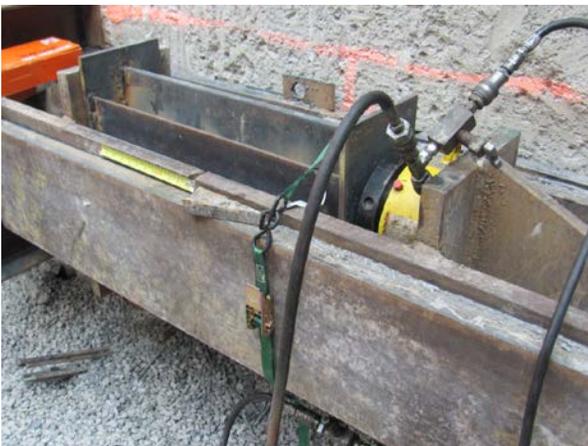
Figure 20: Pre-loading strut

First, the two long struts running east-west across the site were simultaneously pre-loaded in 25% increments, up to 3000 kN per strut. Dial gauges were placed at the east and west secant walls and on the west face of the slab, along with magnetic tapes on the jacking plates to record the displacement.

A maximum of 1.7 mm of movement was measured at the secant reaction wall on the west side of the site, and a maximum of 1.4 mm of flexural movement of the structural slab. Total jack extension at the jacking location was 15 mm on the south strut and 10 mm on the north strut. The

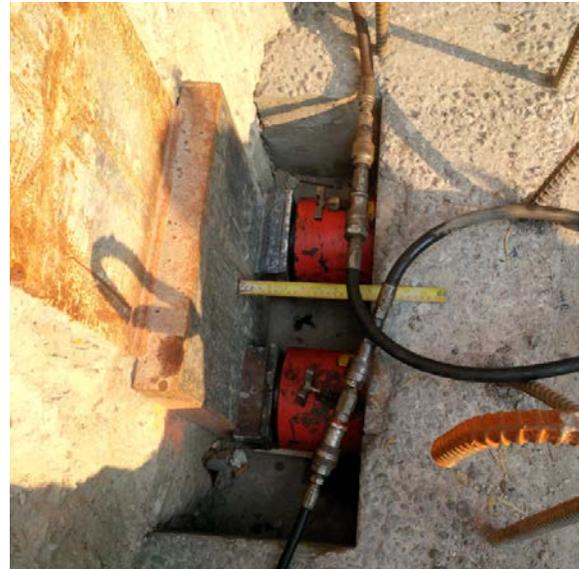
Figure 21: Pre-loading jacks at east wall

To ensure balanced pre-loading, the east wall was pre-loaded simultaneously against the structural slab, using 26 jacks at 13 locations connected in parallel to one pump. The jack loads were increased in tandem in 25% increments to 450 kN each. Total average jack extension at each jacking location ranged from 2 mm to 5 mm.

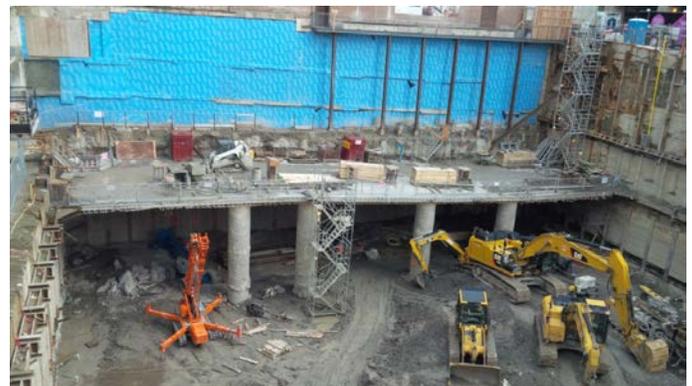
Figure 22: East wall, excavating below P3 slab

Real-time survey monitoring was carried out during the east wall pre-loading process. Up to 2 mm of flexural movement was noted on temporary targets installed on the west edge of the slab. Magnetic tape measures were placed at every jacking location. Negligible movement ( $\leq 2.0$  mm) was noted on both the east wall shoring piles and targets on the 145 Cumberland St. structure to the east.

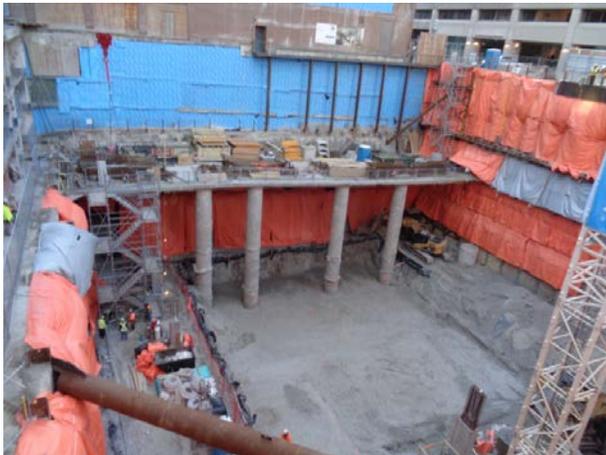
Figure 24: East wall, at final grade, March 2015

Upon reaching final grade of the east wall in January 2015, the shoring at the slab had moved 9 mm into site from an initial average of 4 mm before installation. The maximum movement of the shoring below the slab was 12 mm and the building to the east had moved  $\leq 4$  mm, beating the target set by the owner.
